# DAMAGE ASSESSMENT FORM

Building Name PALM LODGE

Address 17390 SW 296 STREET

City (or Vicinity) and County DADE COUNTY, MIAMI, FL

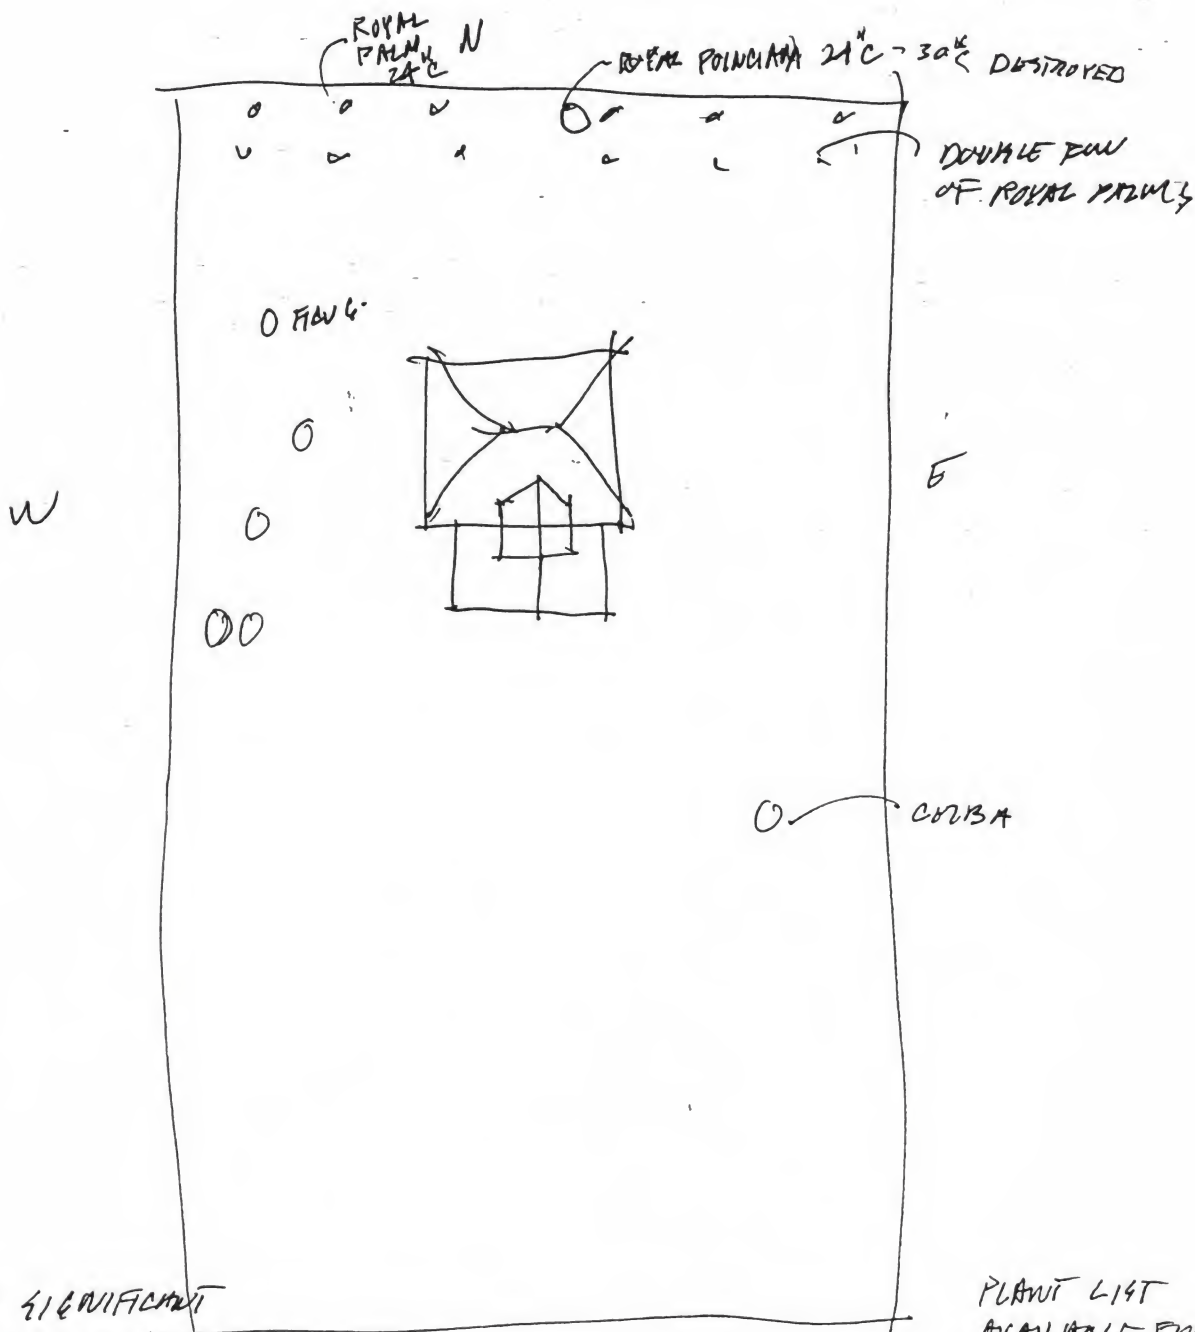
## Site Sketch:

LANDSCAPE IS SIGNIFICANT IN THE NUMBER AND VARIETY OF EXOTIC SPECIES. PLANT MATERIAL WAS UNDER THE DIRECTION OF FAIRGHAIR.

PLANT LIST AVAILABLE FROM OWNER. ITS STORY FROM OWNER AND PEOPLE WHO HAVE TOUCHED THE PROPERTY.
